**Flood Control Project Maintenance
Levee Inspections**

Maintenance Issue Types Only, Levee Inspection Report By Mile - Spring 2018

Reclamation District No. 0551 Pearson

Waterway	Bank	Unit Miles	Inspection Start/End	Inspector
Unit No. 01 Sacramento River	Left	6.78	03/21/2018 03/21/2018	Keith Millard

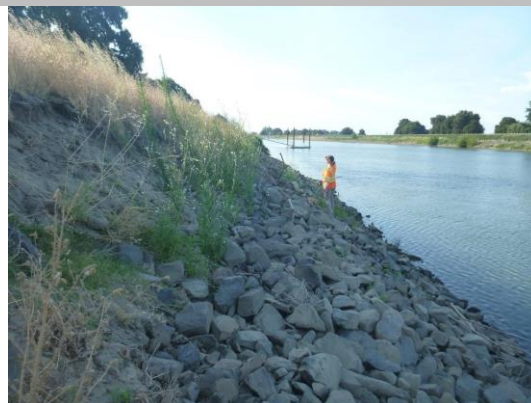
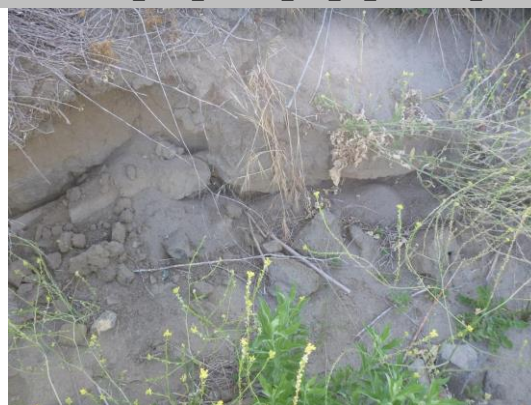
Comment Code					
Inspector Comment					
<p>Levee Evaluation Comments</p> <p>Description: District Station 258+80 to 260+40, Sec. 16, T. 5 N. R. 4 E., M.D.M. Approximately 160 linear-feet of erosion exists along the waterside slope of the Sacramento River. The erosion commences approximately halfway down the slope from the crown and extends to the rip rap. Some existing rip rap has been pulled off in this section.</p> <p>Site ID No: 339</p> <p>Site Designation: LMA-166</p> <p>Repair Type: Erosion</p> <p>Rating: Area of Concern</p> <p>Field Date: 7/14/2017</p> <p>Notes: crown is a paved road. Scarps of 2.5 ft just above rip rap. Area of concern because erosion is fairly small.</p>

Notes: crown is a paved road. Scarps of 2.5 ft just above rip rap. Area of concern because erosion is fairly small.

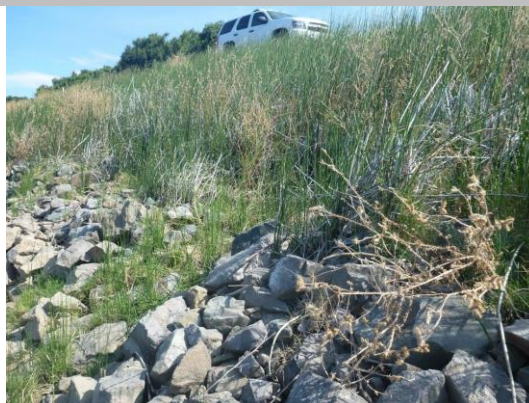
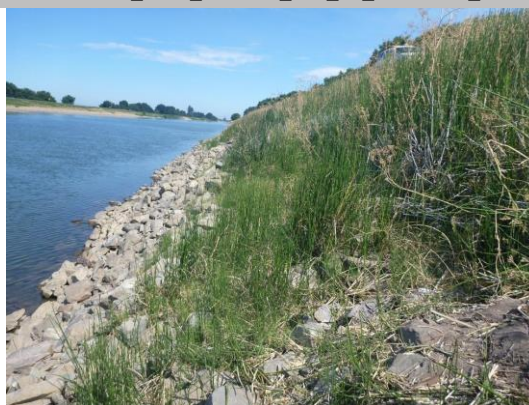
Comment Code					
Inspector Comment					
<p>Levee Evaluation Comments</p> <p>Description: District Station 290+80 to 291+85, Sec. 22, T. 5 N. R. 4 E., M.D.M. Approximately 105 linear-feet of erosion and sloughing exists along the waterside slope of the Sacramento River. The erosion commences approximately 3/4 of the way down the slope and extends into the rip rap. Some existing rip rap has been pulled off in this section.</p> <p>Site ID No: 344</p> <p>Site Designation: LMA-171</p> <p>Repair Type: Erosion</p> <p>Rating: Area of Concern</p> <p>Field Date: 7/14/2017</p> <p>Notes: Crown is a paved road. Erosion scarps 1-4 ft deep just above rip rap. Area of concern because erosion is not very deep into prism.</p>

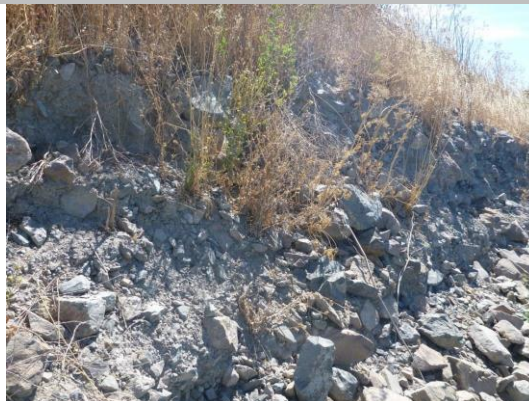
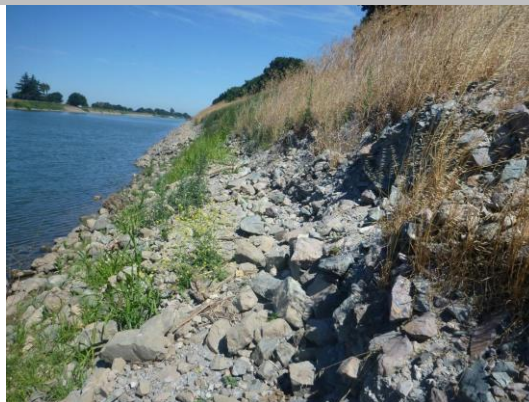
Comment Code						
Inspector Comment						
Levee Evaluation Comments						
Description:District Station 307+90 to 305+49, Sec. 22, T. 5 N. R. 4 E., M.D.M. Approximately 59 linear-feet of erosion exists along the waterside slope of the Sacramento River. The erosion occurs approximately halfway down the slope within the rip rapped area. Existing rip rap has been pulled off in this section.						
Site ID No:346						
Site Designation:LMA-173						
Repair Type: Erosion						
Rating:Area of Concern						
Field Date:7/14/2017						
Notes: Crown is a paved road. Erosion scarps 4-6 ft high, but soil is more stable than other nearby sites with large gravel in silt or clay so we rated this as an area of concern.

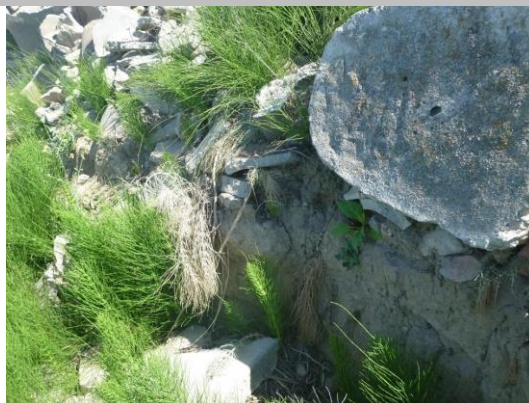
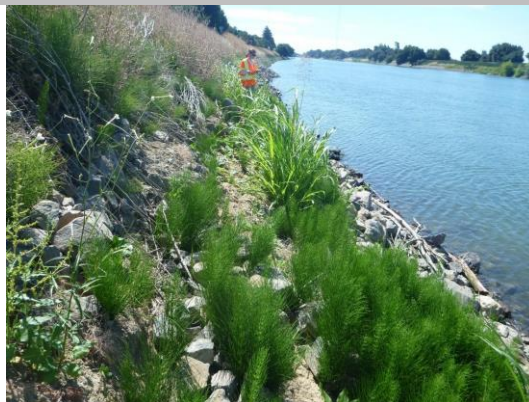
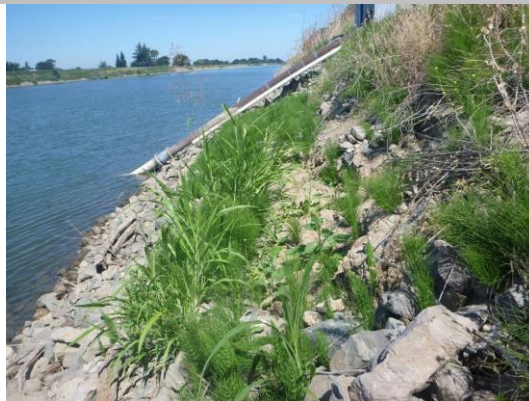
Comment Code						
Inspector Comment						
Levee Evaluation Comments						
Description:District Station 309+33 to 310+53, Sec. 22, T. 5 N. R. 4 E., M.D.M. Approximately 120 linear-feet of erosion and sloughing exists along the waterside slope of the Sacramento River. The erosion commences approximately halfway down the slope, extending into the rip rap. Some existing rip rap has been pulled off in this section.						
Site ID No:347						
Site Designation:LMA-174						
Repair Type: Erosion						
Rating:Area of Concern						
Field Date:7/14/2017						
Notes: Crown is a paved road. Pump house in the middle of this site. 18 inch scarps in and just above top of rip rap. Area of concern because erosion is not very deep into prism.

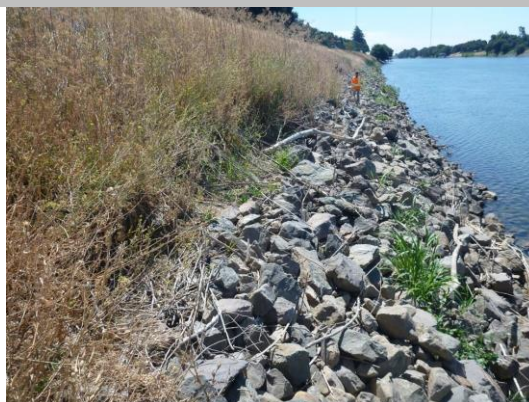
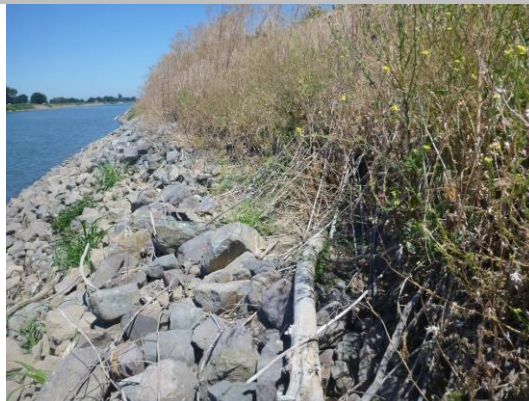
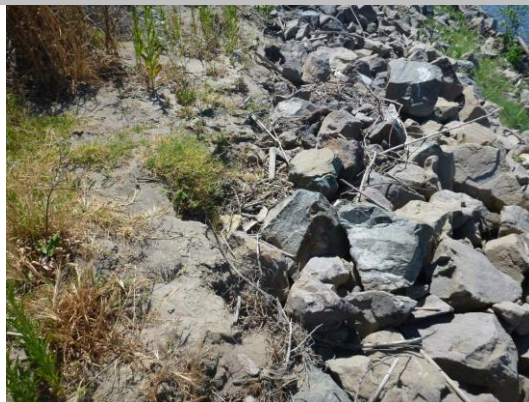
Comment Code					
Inspector Comment					
Levee Evaluation Comments					
Description:District Station 313+15 to 314+15, Sec. 22, T. 5 N. R. 4 E., M.D.M. Approximately 100 linear-feet of erosion and sloughing exists along the waterside slope of the Sacramento River. The erosion commences approximately halfway down the slope and extends into the rip rap. Some existing rip rap has been pulled off in this section.					
Site ID No:349					
Site Designation:LMA-176					
Repair Type:Erosion					
Rating:Area of Concern					
Field Date:7/14/2017					
Notes: 18 in to 3 ft vertical scarps just above rip rap. Crown is a paved road. Area of concern because erosion is not very deep into prism.

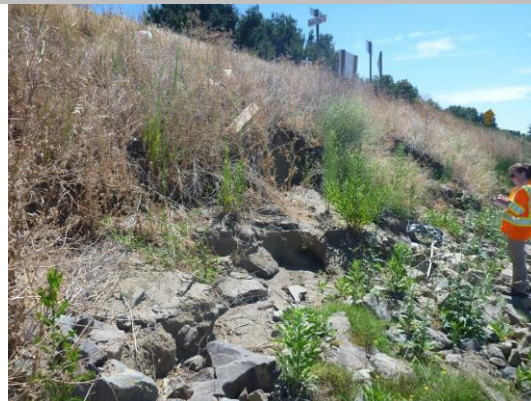
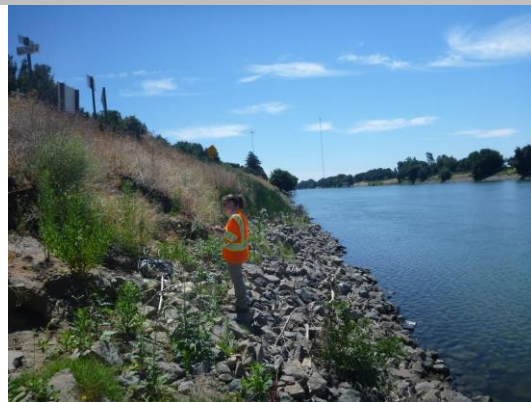
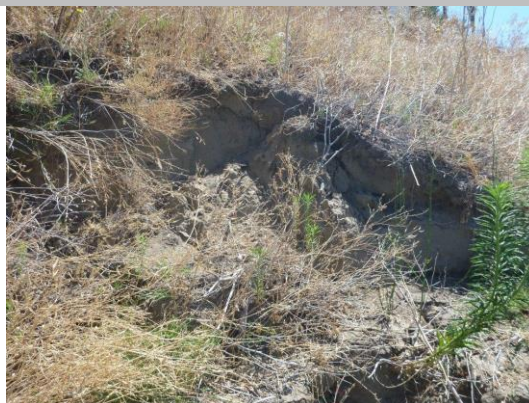
Comment Code					
Inspector Comment					
Levee Evaluation Comments					
Description:District Station 316+24 to 320+12, Sec. 22, T. 5 N. R. 4 E., M.D.M. Approximately 388 linear-feet of erosion exists along the waterside slope of the Sacramento River. The erosion commences approximately halfway down the slope and extends into the rip rap. Some existing rip rap has been pulled off in this section.					
Site ID No:350					
Site Designation:LMA-177					
Repair Type: Erosion					
Rating:Area of Concern					
Field Date:7/14/2017					
Notes: Crown is aved road. Erosion scarps between 1-6 ft deep. Area of concern because the deeper erosion only extended for a short distance.

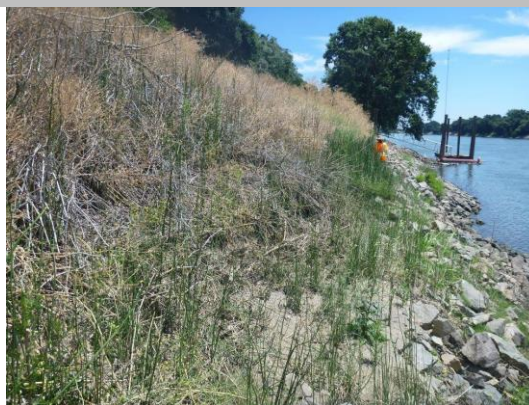
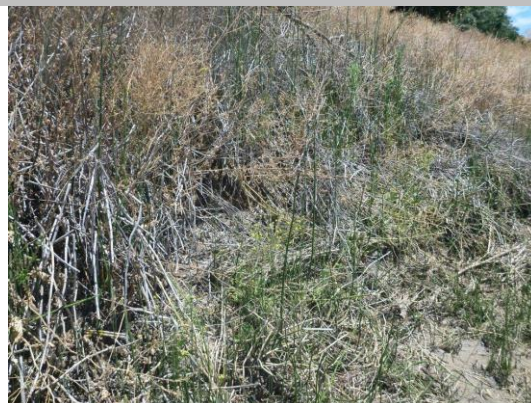
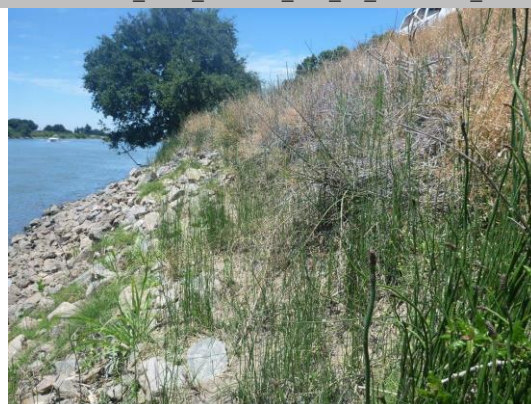
Comment Code					
Inspector Comment					
<p>Levee Evaluation Comments</p> <p>Description: District Station 327+45 to 328+45, Sec. 22, T. 5 N. R. 4 E., M.D.M. Approximately 100 linear-feet of erosion and sloughing exists along the waterside slope of the Sacramento River. The erosion commences approximately halfway down the slope and extends into the rip rap. Existing rip rap has been pulled off in this section.</p> <p>Site ID No: 351</p> <p>Site Designation: LMA-178</p> <p>Repair Type: Erosion</p> <p>Rating: Serious</p> <p>Field Date: 7/14/2017</p> <p>Notes: Crown is a paved road. Scarps above rip rap are about 7 ft deep. Rated this serious because erosion scarps are pretty deep, sandy material, steep slope, the rip rap is in poor condition and high traffic on the levee road.</p>

Notes: Crown is a paved road. Scarps above rip rap are about 7 ft deep. Rated this serious because erosion scarps are pretty deep, sandy material, steep slope, the rip rap is in poor condition and high traffic on the levee road.

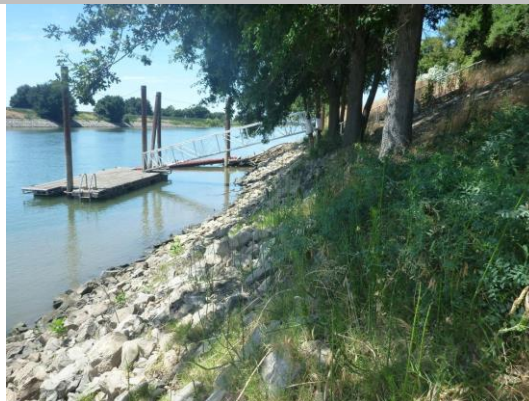
Item	2017 Storm Damage		38.263906 °	38.263756 °								
			-121.524778 °	-121.524575 °								
DWR ID	DWR_RD0551_01_f_2017_43											
Comment Code												
Inspector Comment												
<p>Levee Evaluation Comments</p> <p>Description: District Station 330+19 to 330+99, Sec. 22, T. 5 N. R. 4 E., M.D.M. Approximately 80 linear-feet of erosion/sloughing and minor slippage exists along the waterside slope of the Sacramento River. The erosion/sloughing commences approximately halfway down the slope and extends into the rip rap. Existing rip rap has been pulled off in this section.</p> <p>Site ID No: 352</p> <p>Site Designation: LMA-179</p> <p>Repair Type: Erosion</p> <p>Rating: Area of Concern</p> <p>Field Date: 7/14/2017</p> <p>Notes: Crown is a paved road. Erosion scarps are only 1 ft deep. Area of concern because erosion is not very deep into prism.</p>
